ROBBINS LIBRARY

EXTERIOR ENVELOPE REPAIRS - PHASE 1A BID NO.19-58

ROBBINS LIBRARY
TOWN OF
ARLINGTON
700 MASSACHUSETTS AVENUE
ARLINGTON MA, 02476

EXTERIOR
ENVELOPE
REPAIRS -
PHASE 1A
BID NO. 19-58

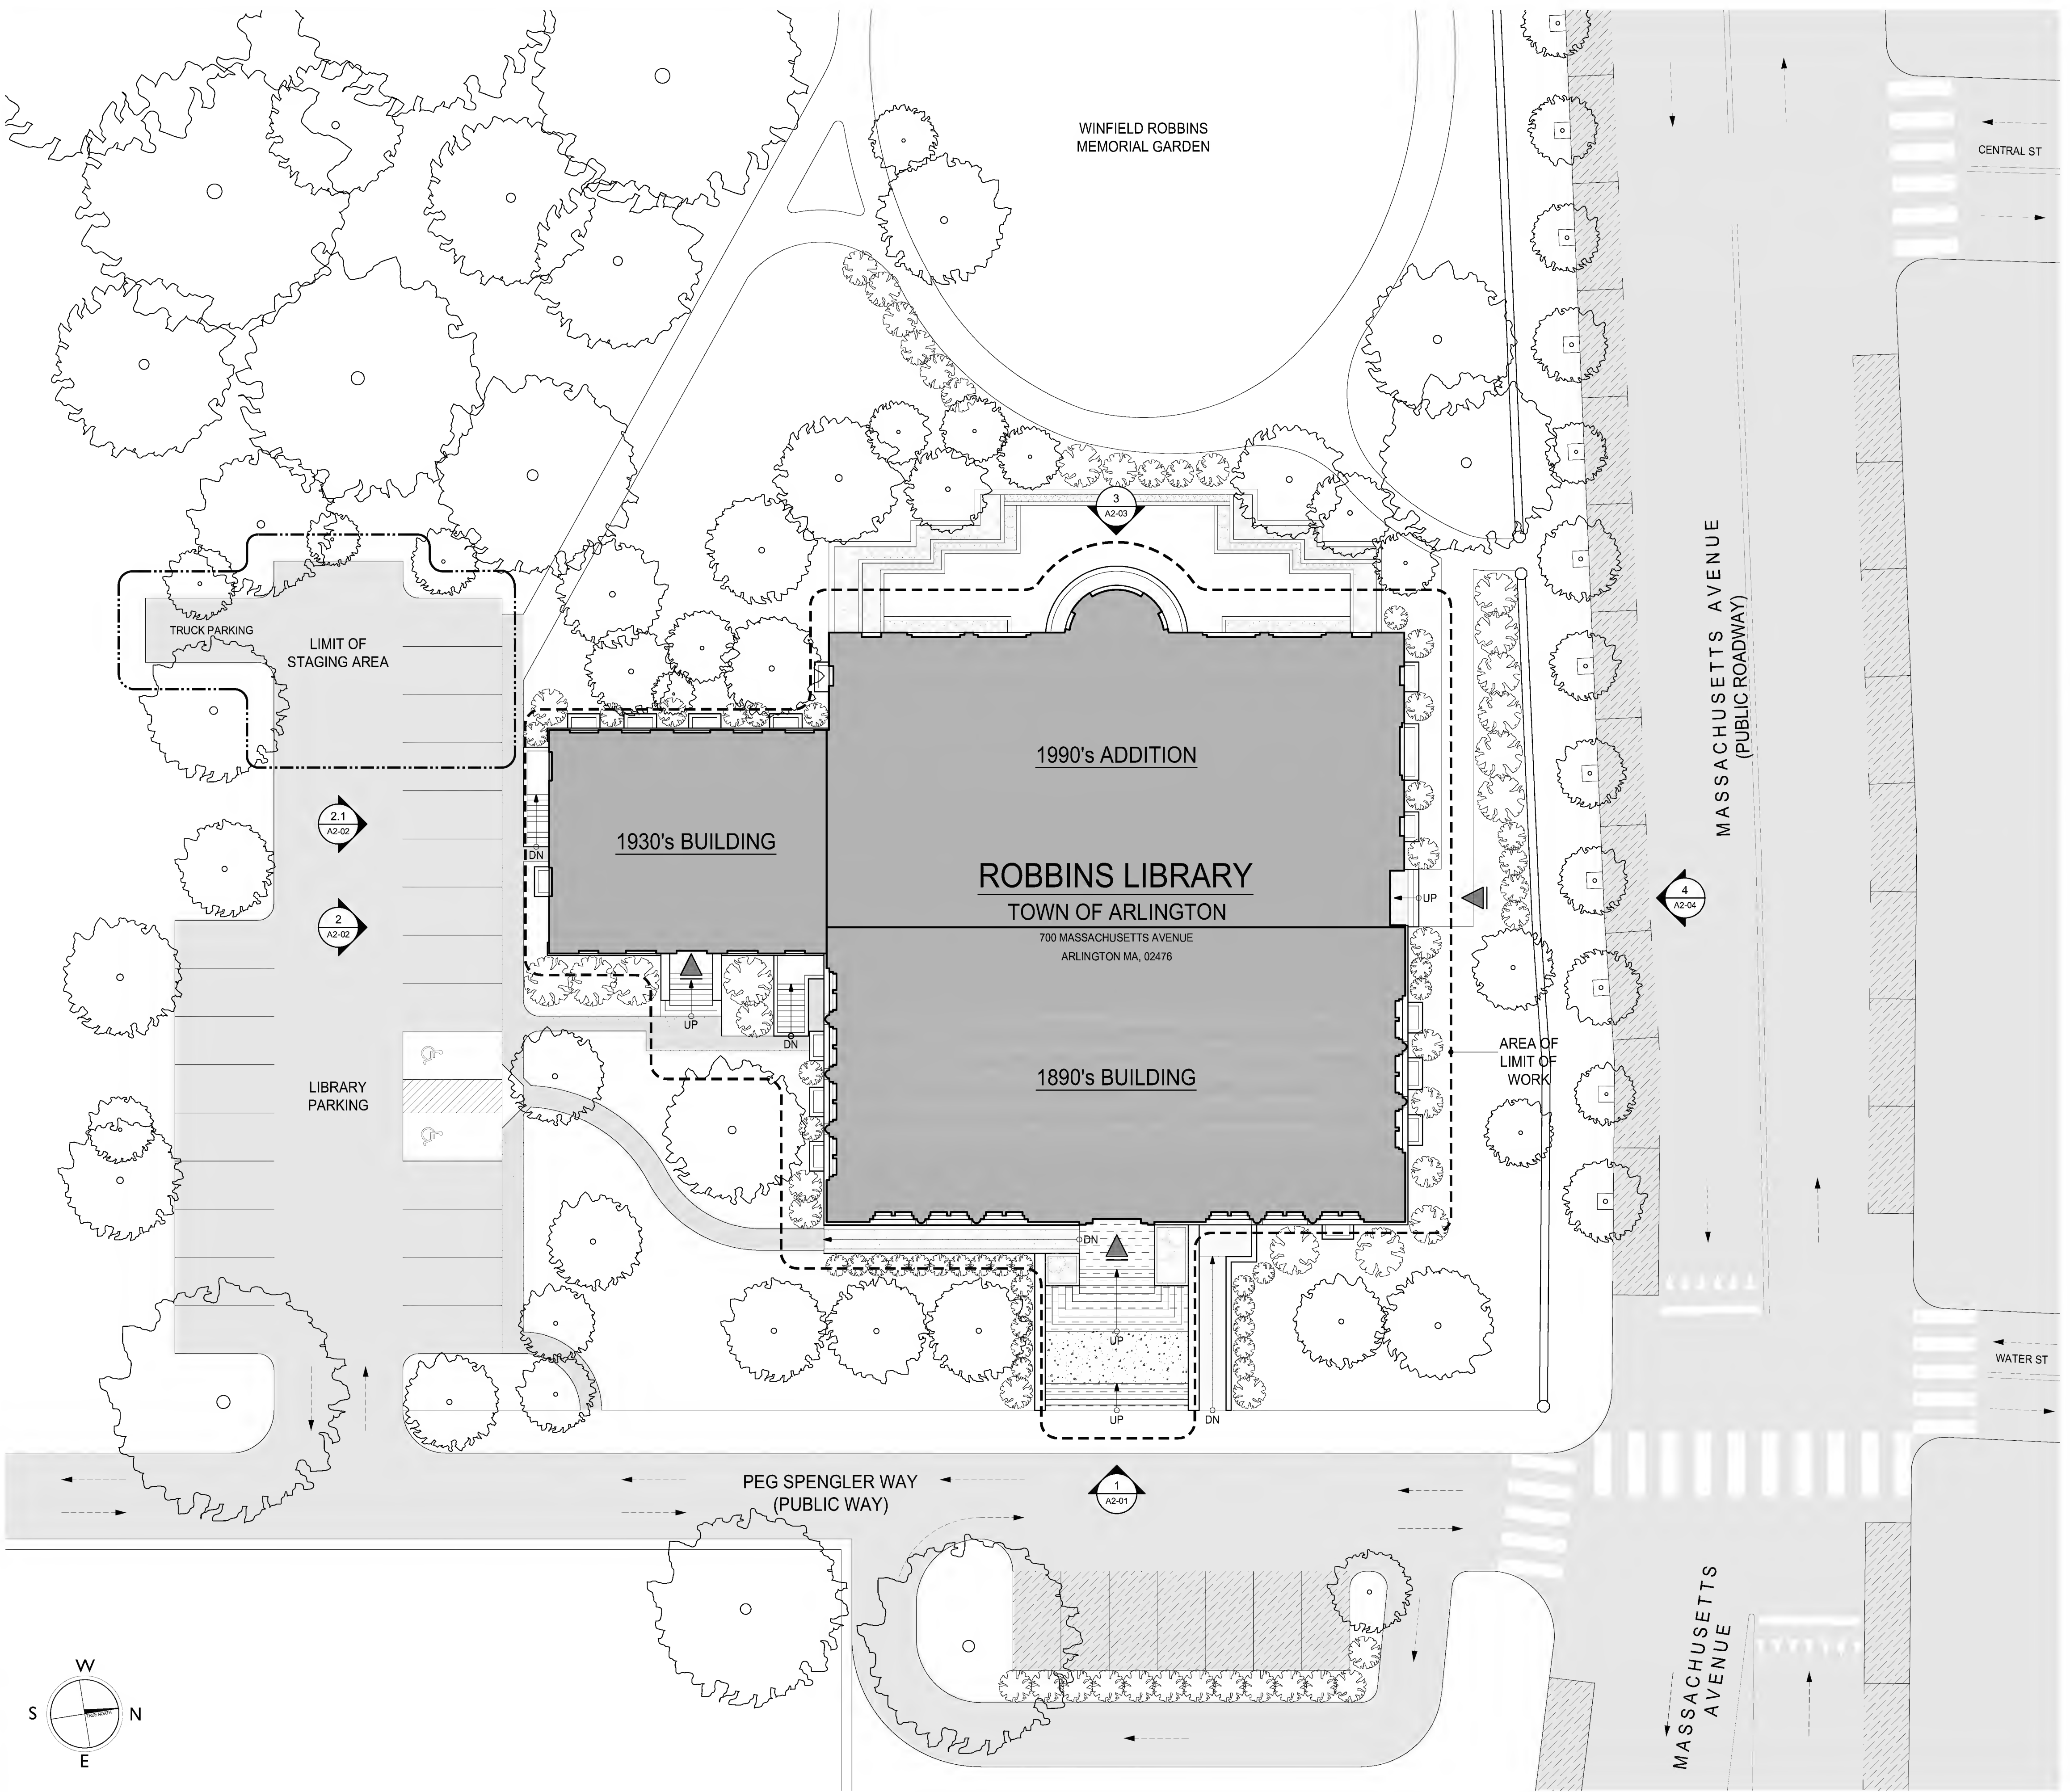
Drawing Title:
**EXISTING
SITE PLAN**

- EXTERIOR ELEVATION LEGEND
- BUILDING ENTRY, TYPICAL
 - EXTERIOR ELEVATION TAG, TYPICAL
 - LIMIT OF WORK, TYPICAL
 - LIMIT OF STAGING AREA, TYPICAL
 - EXISTING PUBLIC PARKING, TYPICAL
 - EXISTING ACCESSIBLE PARKING, TYPICAL
 - DIRECTION OF VEHICULAR TRAFFIC, TYPICAL
 - EXISTING TREE TO REMAIN, TYPICAL
 - EXISTING SHRUBS TO REMAIN, TYPICAL
 - EXISTING GRASS TO REMAIN, TYPICAL
 - EXISTING BRICK PAVEMENT TO REMAIN, TYPICAL
 - EXISTING CONCRETE PAVEMENT TO REMAIN, TYPICAL
 - EXISTING ASPHALT PAVEMENT TO REMAIN, TYPICAL

L1-01 EXISTING SITE PLAN

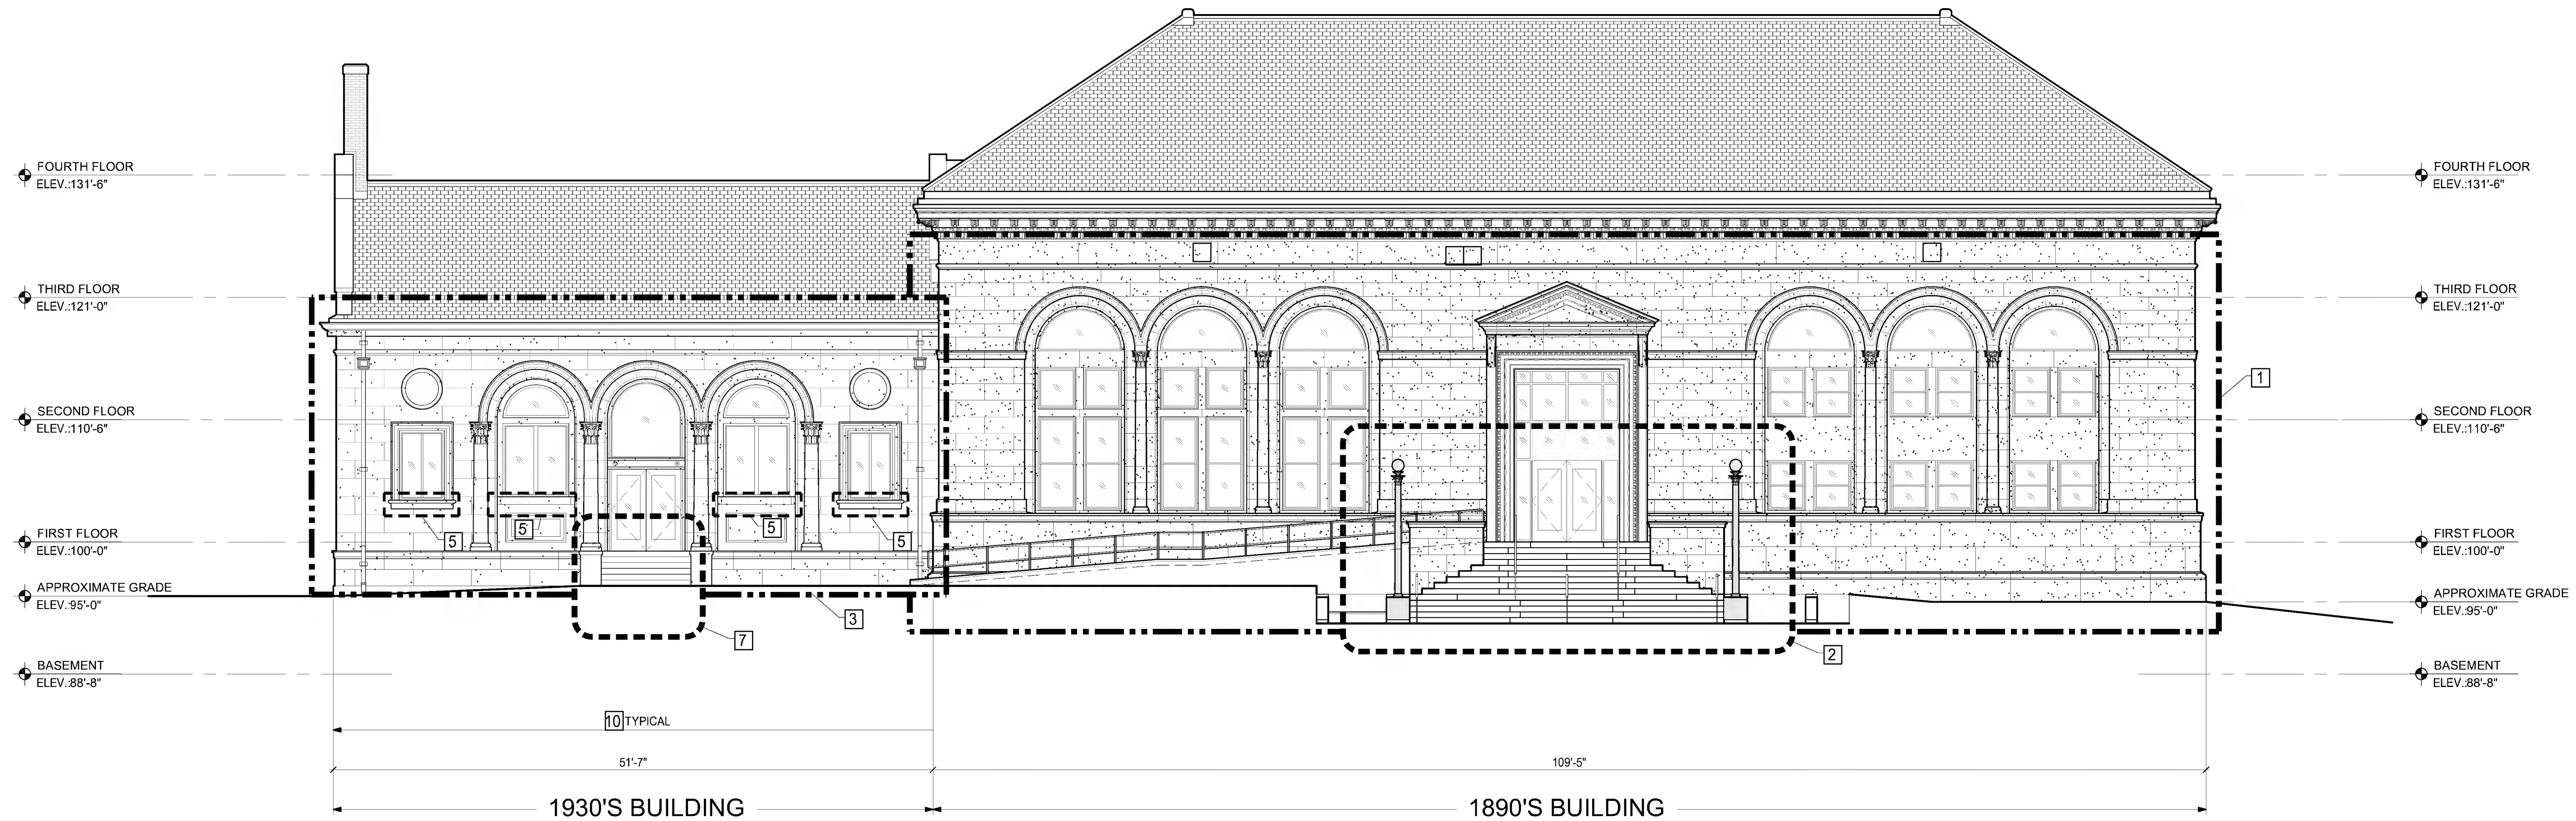
1 EAST EXTERIOR ELEVATION
SCALE: 1/8"=1'-0"

REPAIR AND RESTORATION WORK NOTES:

- ROUTE AND CLEAN EXISTING CRACKS IN ANY SANDSTONE (1890'S BUILDING) DETAIL OR ELEMENT, AND FILL CRACKS WITH INJECTION RESTORATION REPAIR MORTAR. TOTAL QUANTITY OF 50 LINEAL FEET IN SELECT AND RANDOM LOCATIONS ACROSS ALL ELEVATIONS AS SELECTED BY ARCHITECT. REFER TO UNIT PRICES - SPECIFICATION 01 22 00.

- REPLACE EXISTING SEALANT AND MORTAR JOINTS OF THE EXTERIOR GRANITE STONE STAIRS AT MAIN ENTRANCE OF THE 1890'S LIBRARY BUILDING. CUT, REMOVE AND DISPOSE OF 100% ALL EXISTING VERTICAL AND HORIZONTAL JOINT SEALANTS, INCLUDING UNDERLYING MORTAR A MINIMUM OF 1-1/2-INCHES OR UNTIL SOUND MORTAR FROM ALL GRANITE STONE STAIRS. APPLY NEW POINTING MORTAR TO WITHIN 1/2-INCH OF THE SURFACE AND APPLY POLYURETHANE SEALANT TO ALL GRANITE STONE JOINTS. STAIRS SHALL BE POWER WASHED CLEANED. SEE ENLARGE PLAN 1/ A4-01 AND DETAIL 5a & 5b / A4-01.

- ROUTE AND CLEAN EXISTING CRACKS IN ANY ARCHITECTURAL CAST STONE (1930S BUILDING) DETAIL OR ELEMENT, AND FILL CRACKS WITH INJECTION RESTORATION REPAIR MORTAR. TOTAL QUANTITY OF 25 LINEAL FEET IN SELECT AND RANDOM LOCATIONS ACROSS ALL ELEVATION SELECTED BY THE ARCHITECT. SEE DETAIL 1a & 1b/ A4-01. REFER TO UNIT PRICE - SPECIFICATION 01 22 00.

- CUT OUT AND DISPOSE SPALLS, CHIPS AND DELAMINATIONS IN THE ARCHITECTURAL CAST STONE WINDOW SILL. CUT OUT A MINIMUM 1/2" DEEP & SQUARE OFF ALL EDGES. CLEAN SURFACE & APPLY SINGLE COMPONENT, CEMENTITIOUS MINERAL BASED REPAIR MORTAR TOTAL QUANTITY OF 208 CUBIC INCHES IN SELECT AND RANDOM LOCATIONS ACROSS ALL ELEVATION SELECTED BY THE ARCHITECT. REFER TO UNIT PRICE - SPECIFICATION 01 22 00.

- APPLY NEW BACKER ROD WHERE GASKETS ARE MISSING BETWEEN THE PANEL AND FRAME.
 - CLEAN AND PRIME SURFACES AND APPLY NON-SAG SINGLE COMPONENT SILICONE SEALANT. COLOR TO BE SELECTED BY ARCHITECT FROM FULL RANGE OF CUSTOM COLORS.

- REFER TO DEDUCT ALTERNATE NO. 2.
 - CUT OUT AND DISPOSE SPALLS, CHIPS AND DELAMINATION IN THE ARCHITECTURAL CAST IN PLACE STONE EXIT STAIRS OF THE 1930'S BUILDING. CUT OUT A MINIMUM 1" DEEP & SQUARE OFF ALL EDGES. CLEAN SURFACE & APPLY SINGLE COMPONENT, CEMENTITIOUS MINERAL BASED REPAIR MORTAR.

- REPLACE EXISTING SEALANT AND MORTAR JOINTS AT THE EXIT STAIRS OF THE 1930'S BUILDING. CUT, REMOVE AND DISPOSE OF 100% ALL EXISTING VERTICAL AND HORIZONTAL JOINT SEALANTS, INCLUDING UNDERLYING MORTAR A MINIMUM OF 1-1/2-INCHES OR UNTIL SOUND MORTAR FROM ALL ARCHITECTURAL CAST IN PLACE STONE STAIRS AND LANDING. APPLY NEW POINTING MORTAR TO WITHIN 1/2-INCH OF THE SURFACE AND APPLY POLYURETHANE SEALANT TO ALL CAST IN PLACE STONE STAIRS AND LANDING JOINTS. STAIRS SHALL BE POWER WASHED CLEANED. SEE DETAIL 3 & 4 / A4-01.

A2-01 EAST EXTERIOR ELEVATION
A2-02 SOUTH EXTERIOR ELEVATION
A2-03 WEST EXTERIOR ELEVATION
A2-04 NORTH EXTERIOR ELEVATION
A4-01 REPAIR & RESTORATION DETAILS

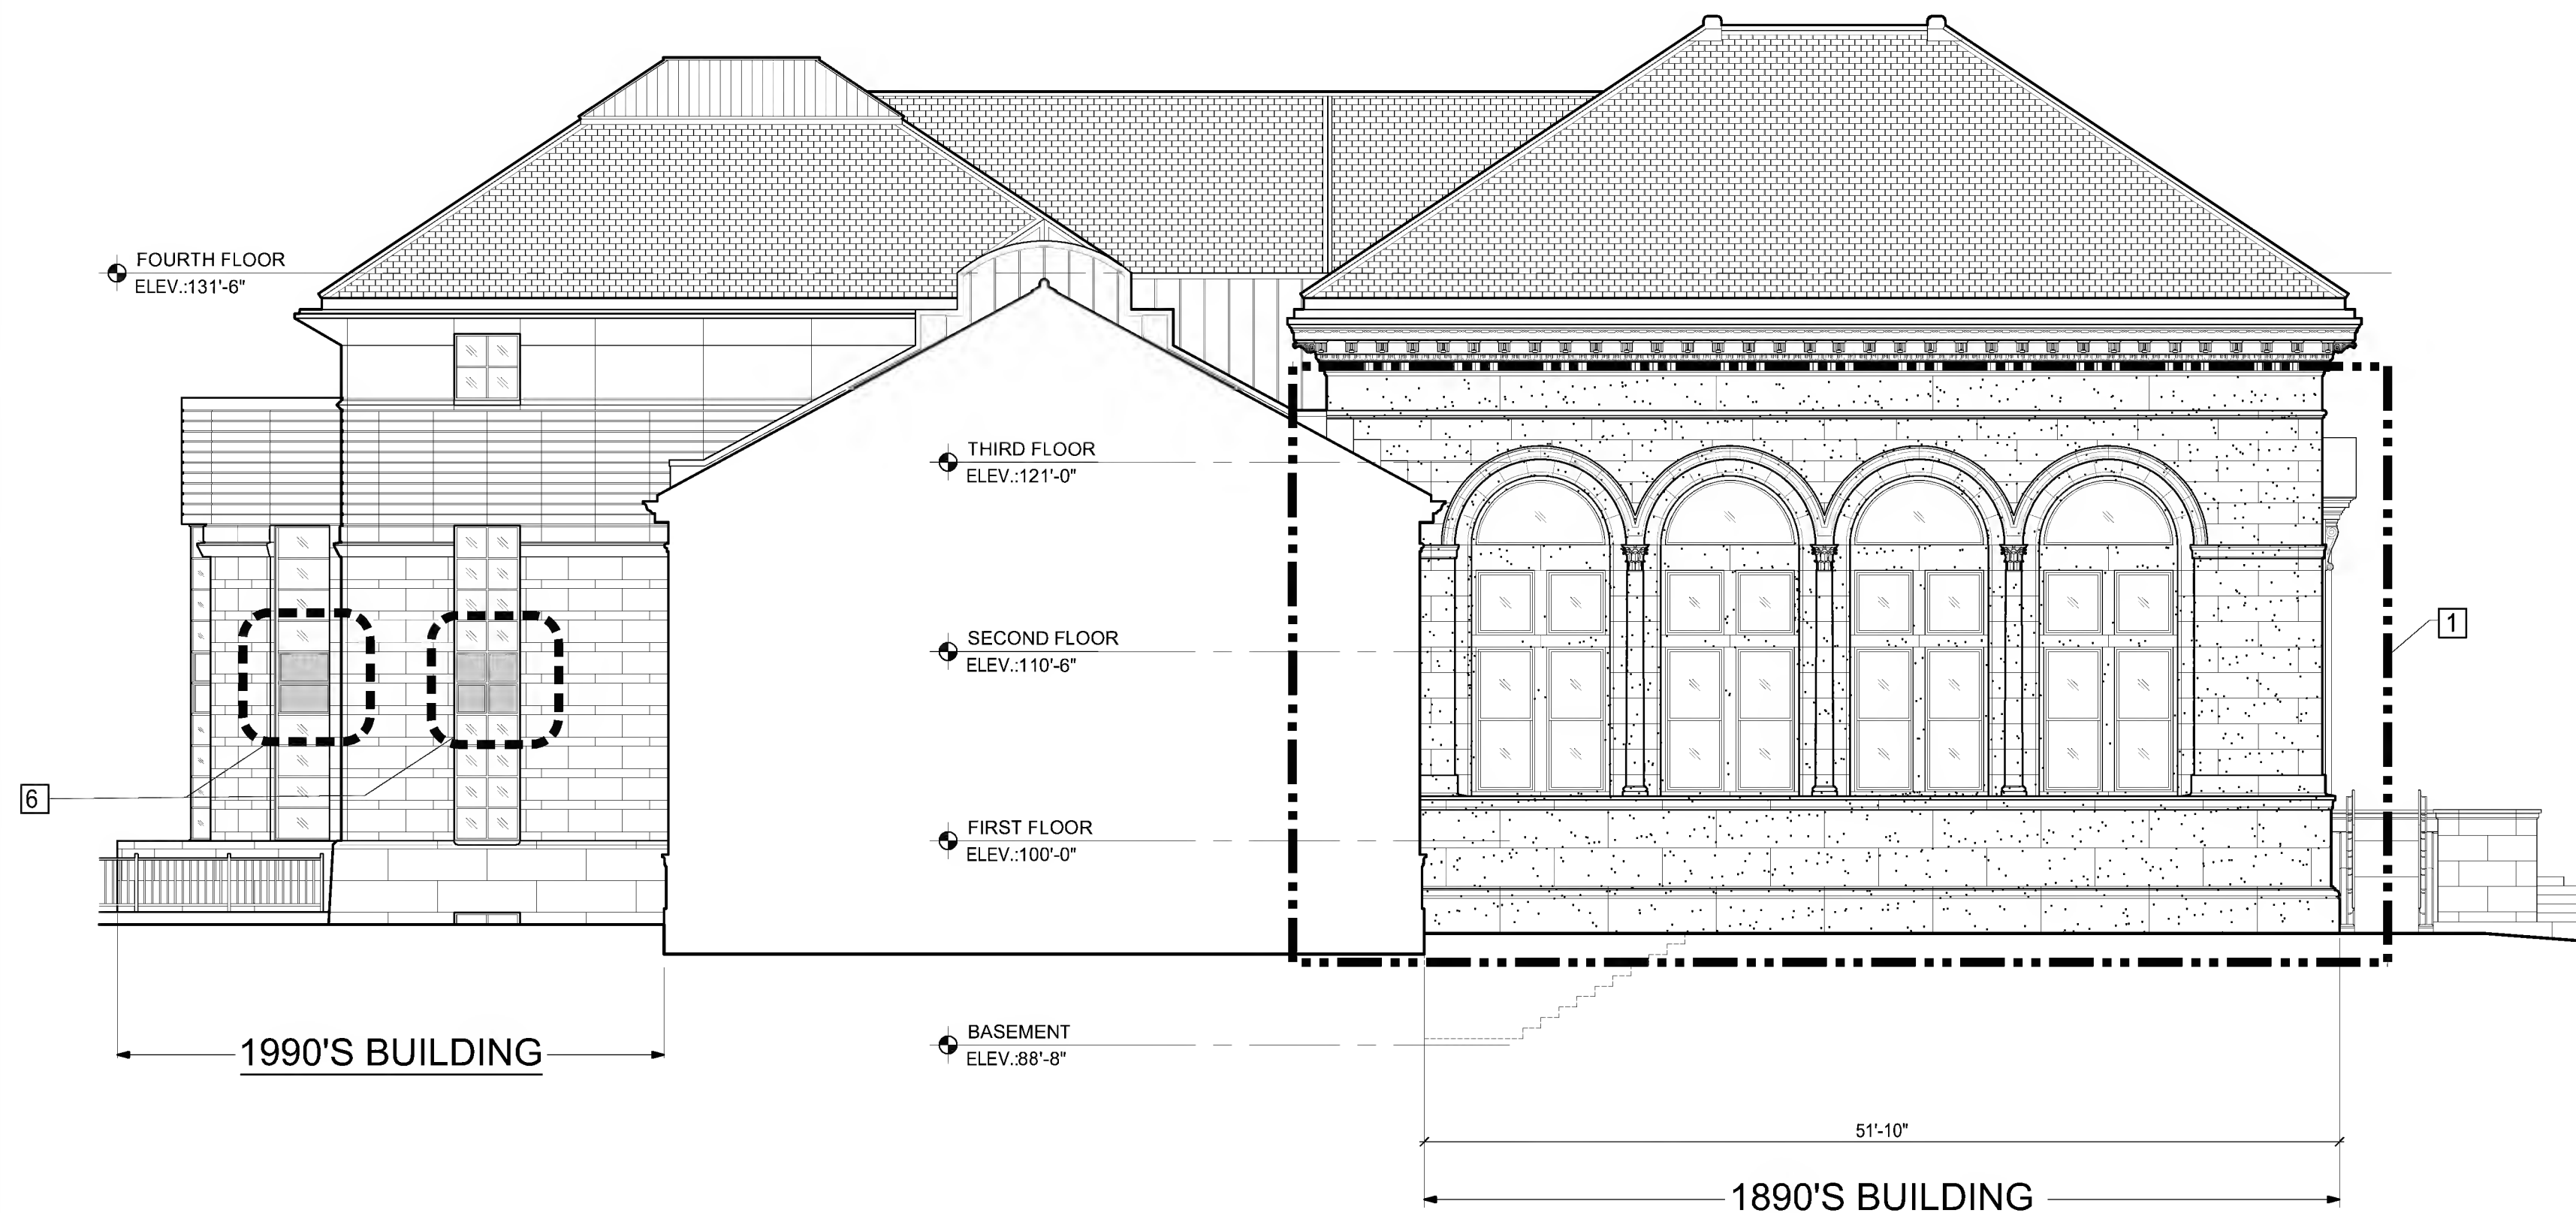
2 SOUTH EXTERIOR ELEVATION
SCALE: 1/8"=1'-0"

REPAIR AND RESTORATION WORK NOTES:

1. ROUTE AND CLEAN EXISTING CRACKS IN ANY SANDSTONE (1890'S BUILDING) DETAIL OR ELEMENT, AND FILL CRACKS WITH INJECTION RESTORATION REPAIR MORTAR. TOTAL QUANTITY OF 50 LINEAL FEET IN SELECT AND RANDOM LOCATIONS ACROSS ALL ELEVATIONS AS SELECTED BY ARCHITECT. REFER TO UNIT PRICES - SPECIFICATION 01 22 00.

2. REPLACE EXISTING SEALANT AND MORTAR JOINTS OF THE EXTERIOR GRANITE STONE STAIRS AT MAIN ENTRANCE OF THE 1890'S LIBRARY BUILDING. CUT, REMOVE AND DISPOSE OF 100% ALL EXISTING VERTICAL AND HORIZONTAL JOINT SEALANTS, INCLUDING UNDERLYING MORTAR A MINIMUM OF 1-1/2-INCHES OR UNTIL SOUND MORTAR FROM ALL GRANITE STONE STAIRS. APPLY NEW POINTING MORTAR TO WITHIN 1/2-INCH OF THE SURFACE AND APPLY POLYURETHANE SEALANT TO ALL GRANITE STONE JOINTS. STAIRS SHALL BE POWER WASHED CLEANED. SEE ENLARGE PLAN 1/A401 AND DETAIL 5a & 5b / A4-01.

3. ROUTE AND CLEAN EXISTING CRACKS IN ANY ARCHITECTURAL CAST STONE (1930S BUILDING) DETAIL OR ELEMENT, AND FILL CRACKS WITH INJECTION RESTORATION REPAIR MORTAR. TOTAL QUANTITY OF 25 LINEAL FEET IN SELECT AND RANDOM LOCATIONS ACROSS ALL ELEVATION SELECTED BY THE ARCHITECT. SEE DETAIL 1a & 1b / A4-01. REFER TO UNIT PRICE - SPECIFICATION 01 22 00.

- b. APPLY NEW BACKER ROD WHERE GASKETS ARE MISSING BETWEEN THE PANEL AND FRAME.
 - c. CLEAN AND PRIME SURFACES AND APPLY NON-SAG SINGLE COMPONENT SILICONE SEALANT. COLOR TO BE SELECTED BY ARCHITECT FROM FULL RANGE OF CUSTOM COLORS.
